Northridge Earthquake!

Reinforced Masonry Performs Well

*by John Chrysler**

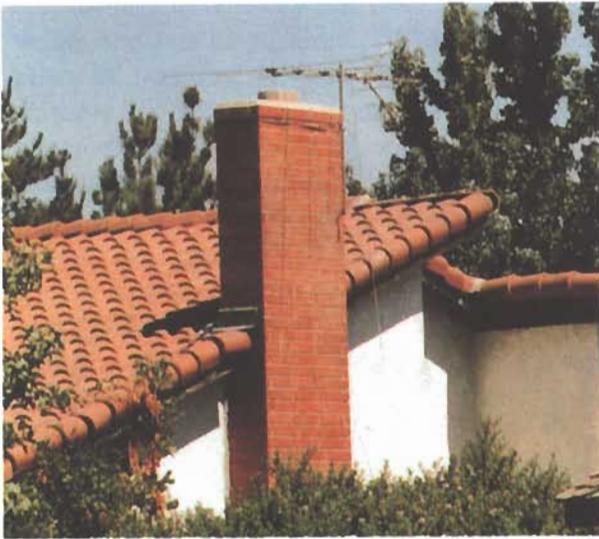
Across the street from Cal State Northridge Parking Structure brick chimney stands tall.

One of the most visible failures was the Cal State Northridge Parking Structure, a ductile concrete frame system that collapsed at the East and West ends. Opposite the East end of this parking structure, across Zelzah Avenue, are five houses in a row, all with brick chimneys that suffered no damage due to the earthquake.

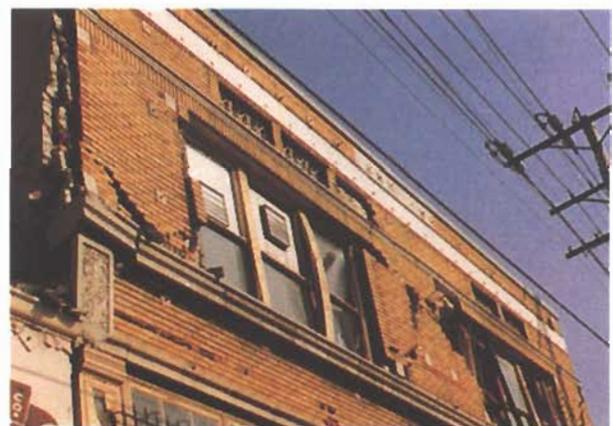
A large portion of the old unreinforced masonry buildings within the City of Los Angeles fell within the jurisdiction of Division 88. Division 88 is an attempt to secure the masonry of the old pre-1933 buildings to the roof and floor diaphragms to keep the building from total collapse in the event of a major earthquake. It was never intended to prevent damage to the structure.

Since the retrofitted buildings performed better than those that were not retrofitted, it is reasonable to say that Division 88 was effective.

Unreinforced, retrofitted building in Los Angeles heavily damaged without collapse.

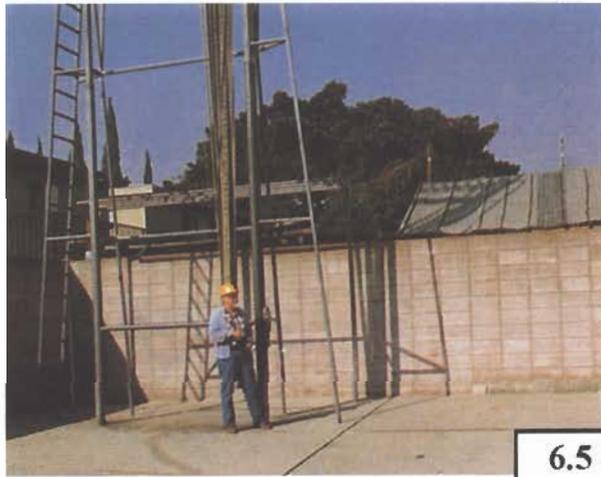
Fire Stations, which use extensive masonry in their design, withstood the earthquake almost flawlessly. The facilities were in full operation the same day of the earthquake.

Typical Fire Station perimeter wall with no damage.

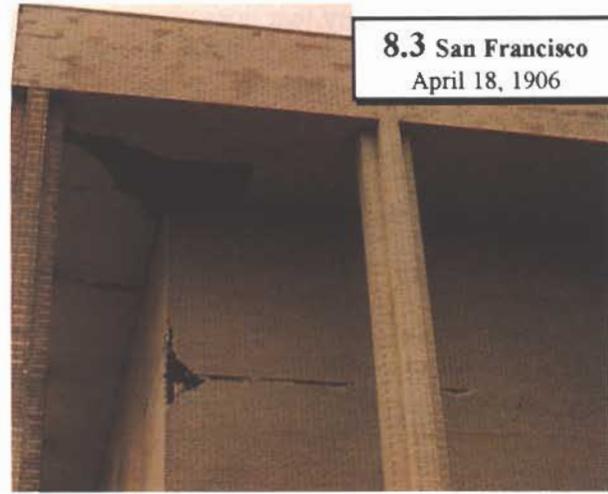
The Northridge Mall, which is less than 3 miles (4.5 km) from the epicenter, suffered extensive damage. The Bullocks Store, a non-masonry structure, collapsed. Yet only a few yards away, the Broadway Store, a double wythe reinforced brick facade with concrete floors and interior concrete columns stood like a fortress. There was extensive damage to the interior and exterior, but it is repairable. Ironically, the Broadway Store was under construction during the 1971 San Fernando Earthquake.

Broadway, Northridge Mall is double wythe reinforced brick and shows damage from floor pounding while adjacent Bullock's Store (not masonry) collapsed.

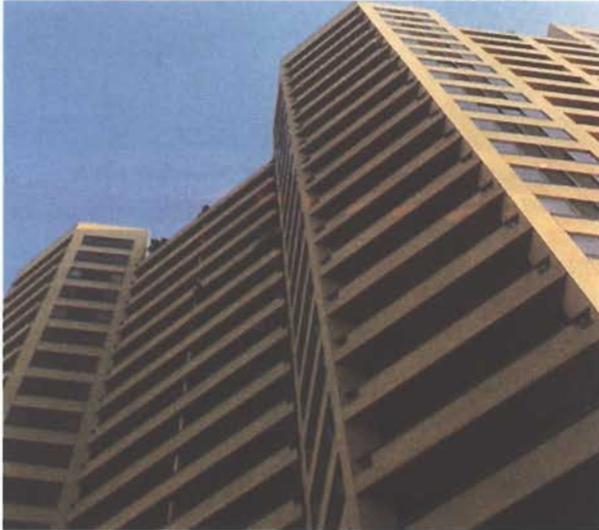
Mirabella, a 23 story undamaged brick veneer tower near heavily damaged Santa Monica.

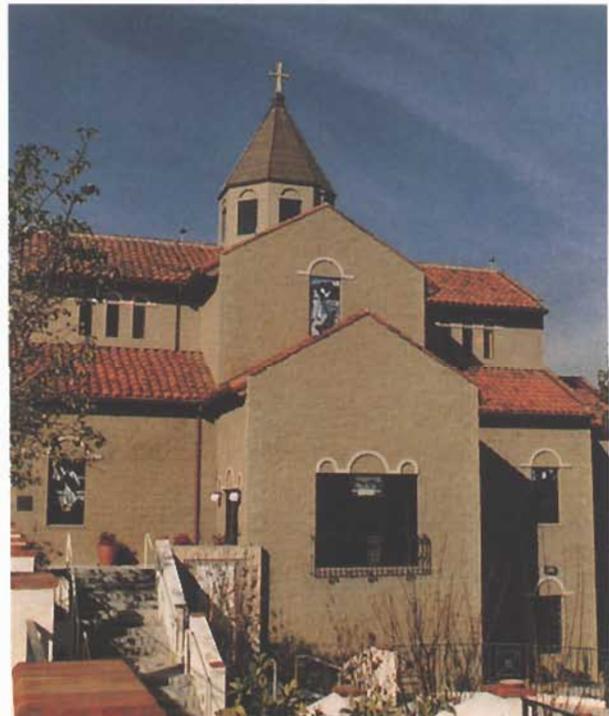
Armenian Church in San Fernando recently built reinforced block with no damage.
